COVER DOCUMENT

System Pillar / EULYNX

Baseline Set 4 Release 2

Version: 2.5
Date: 15-12-2025

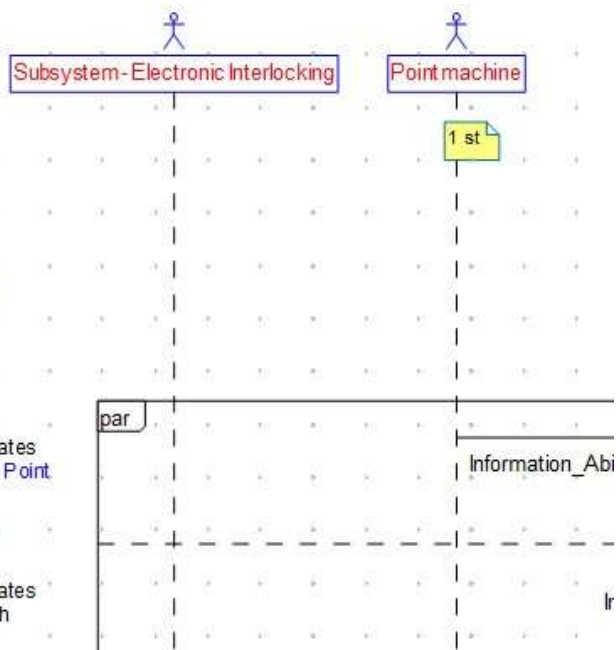
Eu.P.5374_Msg_Point_Position.png

On SD 2.1.2.4.9 (Eu.P.5804) and 2.1.2.4.10 (Eu.P.5374) in on Step 2 a incorrect IO Flow is used (Msg_Point_Position).

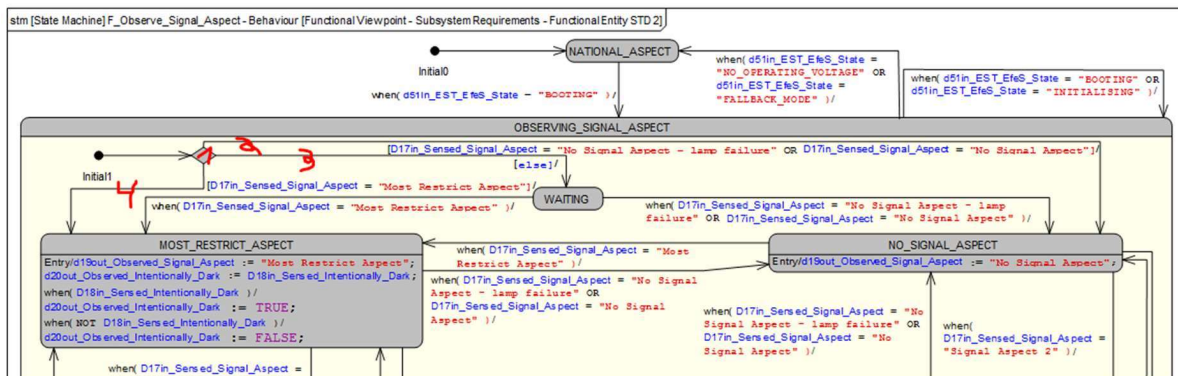
image-2023-08-15-13-44-53-576.png

When the LS will be set from OPERATIONAL (while indicating "most restrict Aspect" back to BOOTING and then back to OPERATIONAL the controller is not able to report the newly set Aspect to the interlocking.

This is caused due to a deadlock in the observing block as it reacts just on the change trigger of D17 and can therefore not leave the state WAITING.

The STM for observe Signal Aspect shall be extended with transitions made of purely guard conditions (reacting on current state and not change trigger) as in attached pic shown. The four marked transitions/elements should be added to correct the described behaviour above.

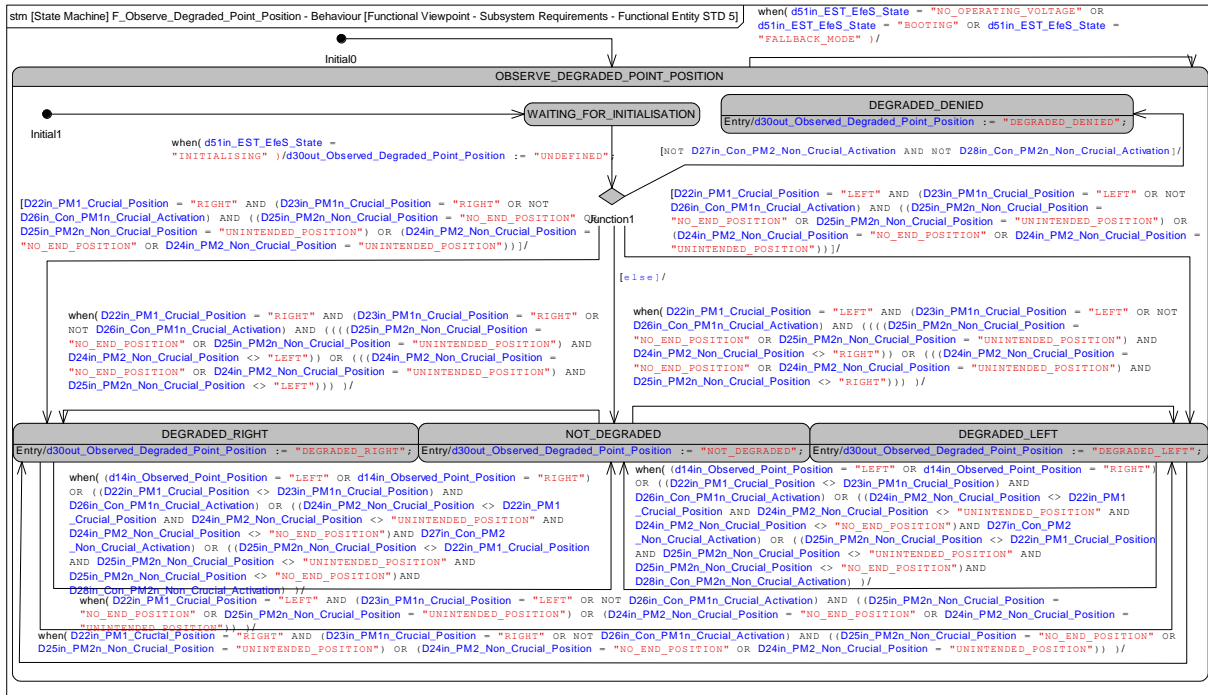
The STM diagram F_Observe_Degraded_Point_Position (Eu.P.6015) contains an error.

This does not exclude that the Point can be reported as 'Degraded Left' if one of the Non-crucial PMs is detected in the opposite position 'Right'. This is incorrect. The functional definition of degraded position does not allow that one of the Non-crucial PMs is detected in a position that is opposite to the end position detected by all Crucial PMs.

Extend the conditions of these 2 transitions to cover D10in_PM1_Non_Crucial_Position <> "LEFT" AND D10in_Pmk_Non_Crucial_Position <> "LEFT" And equivalent correction for <> "RIGHT".

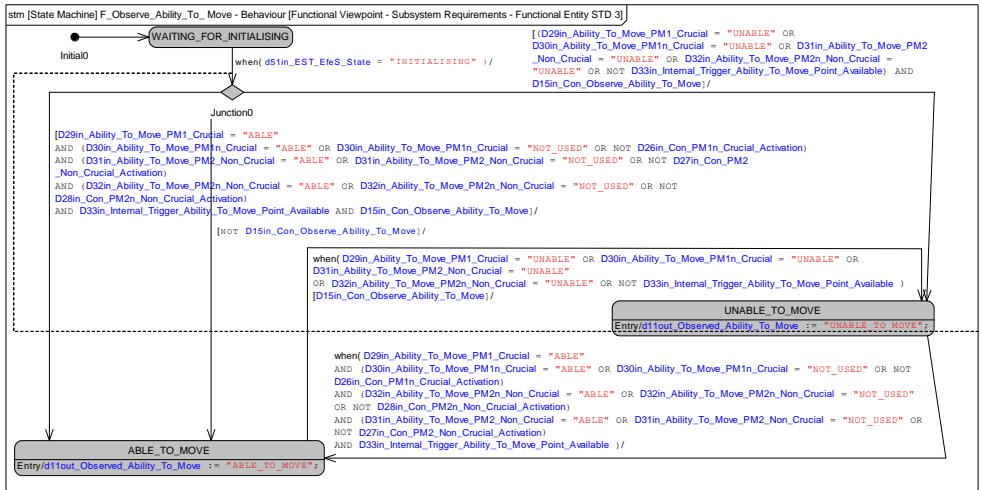
F_Observe_Ability_To_Move

20220905 BFG: Hier muss noch geklärt werden, wann wieder in "WAITING_FOR_INITIALISING" zurück gegangen werden kann! Wenn all das hier nur in INITIALISING und OPERATIONAL stattfinden soll, fehlen die Rücktransitionen!
