# Rail to Digital automated up to autonomous train operation

## D11.3 – PoC of Perception System

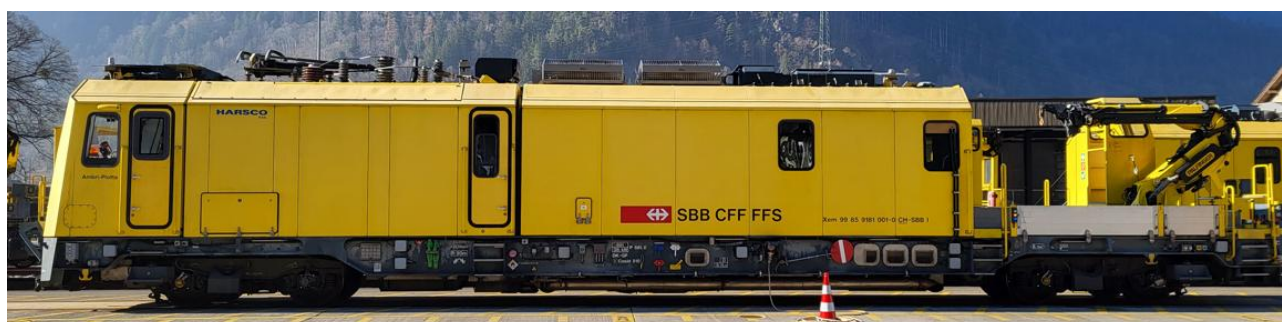
**Figure 1: Used vehicle Xem 181 - 99 85 9181 001**

The Xem 181 is a four-axle traction unit with two bogies and four electrically driven and water-cooled traction motors. The energy supply for the main circuit is provided either from the overhead line with 15 kV / 16.7 Hz or from an underfloor-mounted diesel power pack. For every bogie there is a propulsion converter available. The vehicles are equipped with an automatic draw/push coupling and buffers. They can be coupled without restrictions to vehicles with UIC coupling and buffer devices. The Xem 181 is multi-traction capable. Additional technical parameters can be found in the following table [1]:

| Figure 1: Used vehicle Xem 181 - 99 85 9181 001..... | 12 |

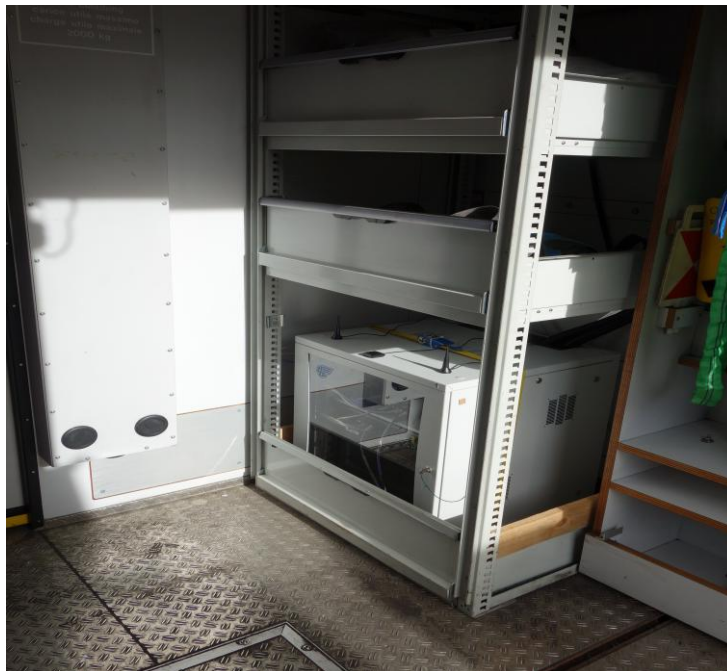
Figure 4: Computer unit in the vehicle

The processing backbone is anchored by an *Intel Core i9-13900E 24-Core CPU*, selected specifically for its capability to manage numerous concurrent data streams, handle complex sensor initializations, and oversee synchronous operations across the entire sensor suite. Graphical acceleration and parallel computing tasks are offloaded to two *Nvidia RTX A4000 GPUs*. These are instrumental in accelerating computationally intensive tasks, namely real-time video encoding and high-speed neural network inference required for anonymization. Persistent data archival is managed by a high-performance four *Kingston DC600M 3.84 TB SSD array*, providing both the necessary total capacity and the required write endurance and speed for parallel data logging within the rail deployment.

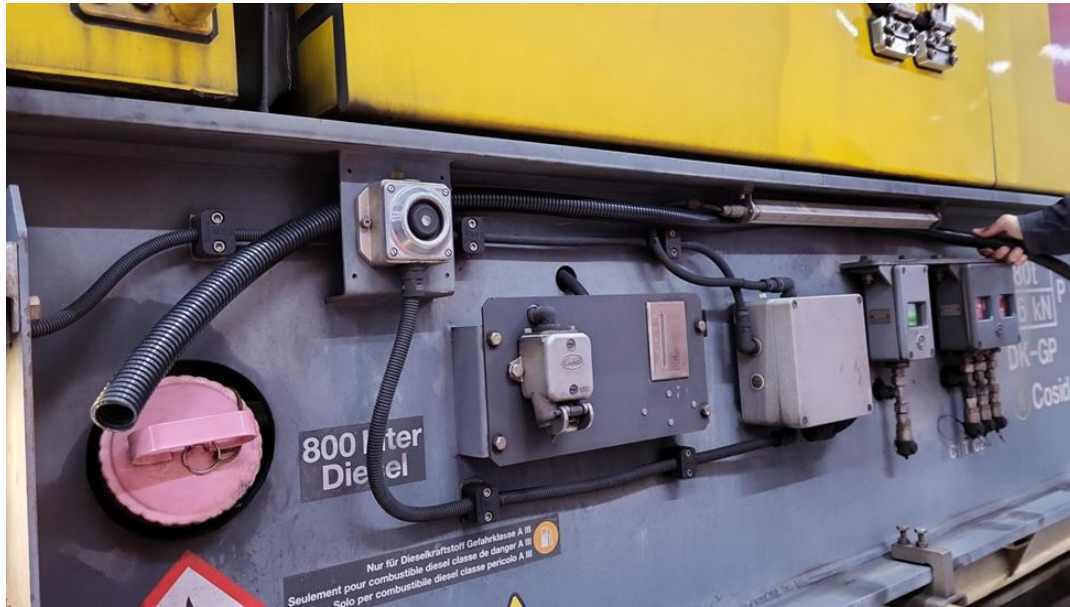
**Figure 6: Definition of cabling route**

To ensure the cabling to be executed efficiently and correctly, a concept for the cabling had to be developed [7]. All cables outside the vehicle must be placed in a protective hose. It was decided to combine the sensor cables from the front and rear part of the vehicle and route them in a separate protective hose. This approach allowed efficient and straightforward cable routing. The cables could not be routed through the vehicle itself due to space constraints, so they had to be fixed externally without violating the profile area. The window at the workshop area was designated as the entry point to the vehicle. To define the best way for the cabling route, a mockup hose was used as indicated in Figure 6 indicated.

The complete cabling concept was checked by the vehicle responsible and approved afterwards.

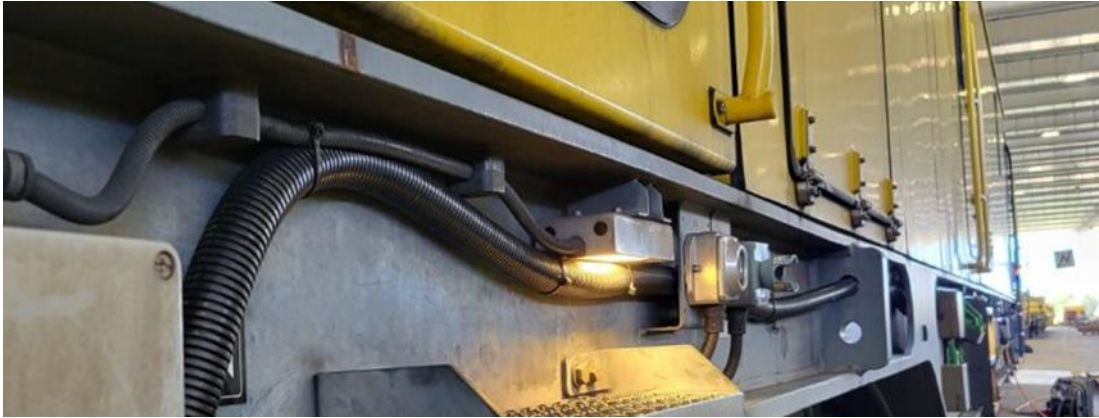
**Figure 7: Example picture for final cabling outside of the vehicle**

The cabling concept allowed the precise definition of the dimensions for the cables. During this period, also the cabling for the direction detection was prepared. All cables were supplied by AŽD, while SBB organized the protective hose and all assembly materials. The entire cabling could be completed within two days. The cables were properly routed to the designated location, as shown as an example in Figure 7.

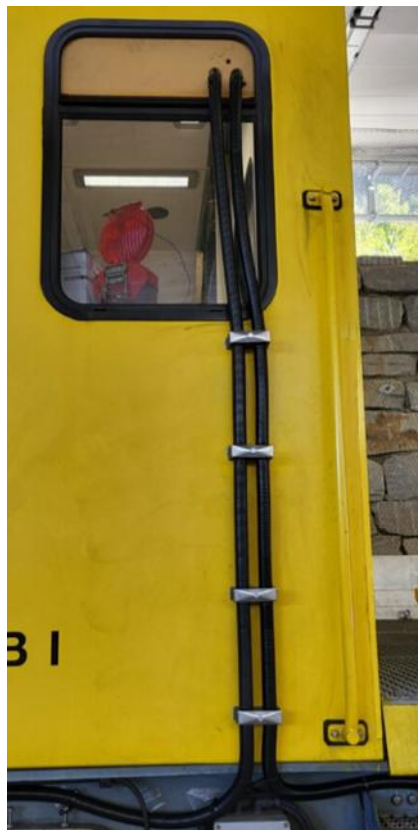
**Figure 8: Cable routing and entrance into the vehicle**

A bigger challenge was to insert the protective hoses into the vehicle, as only the window at the workshop could be used. Additionally, special fastening clips had to be glued to the vehicle, since no other fastening options were available. A non-flammable wooden cover was made and fitted to the window with holes drilled for entry the protective hoses. An additional hole was drilled between the entrance for the protective hose for the temperature sensor. Everything was sealed in a further step. Figure 8 shows the final installation of the vehicle entrance for the cables:

The cabling for the front part had to be routed primarily outside the vehicle, while the rear cabling could mostly run beneath the loading platform.

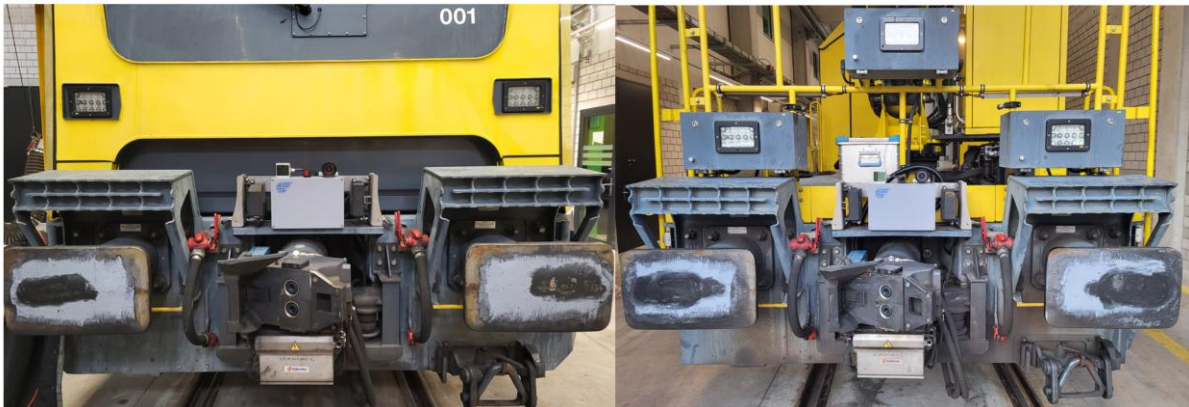
**Figure 9: Position of perception system (left: frontside / right: backside)**

Three days were used for installing the system. The vehicle was located in the workshop at MIC Erstfeld during this period. AŽD installed the mechanical and electrical components in collaboration with SBB. The installation proceeded without major problems and could be carried out as planned. Minor modification could be solved immediately without any impact on the timeline. After the installation, the team in charge of the vehicle approved the installation. The following image shows the position of the system, where the left image shows the frontside and the right image indicates the backside of the vehicle.

The system was installed between two connectors. These connectors are rarely used in operational applications. The plugs are used for the train bus when the automatic train coupling is not functioning, requiring the train bus to be connected manually. Therefore, it was no problem to use these mechanical parts for installation. The system does not affect the personnel in everyday use and does not violate the profile area.

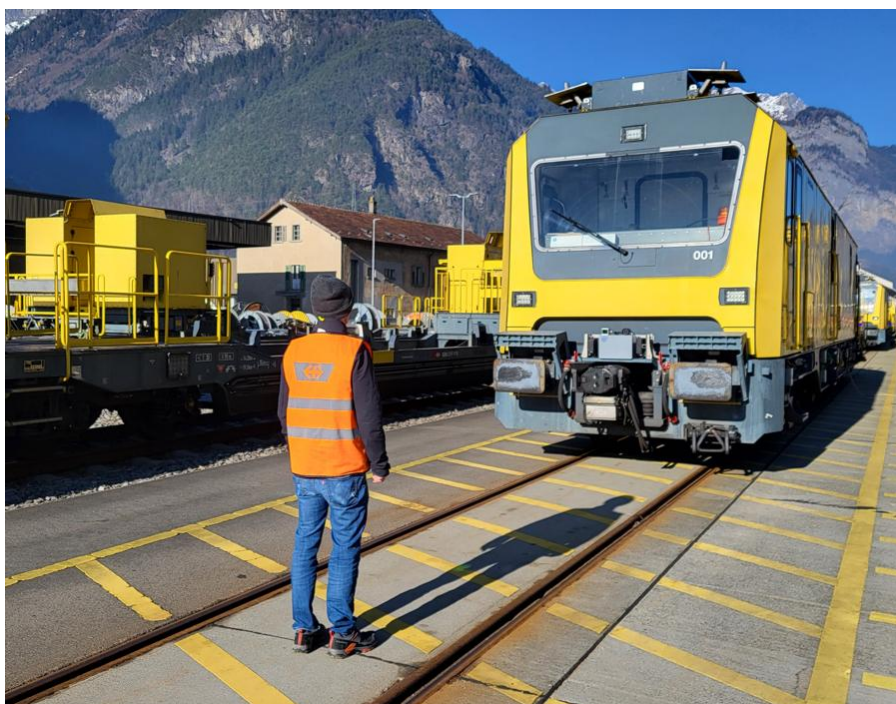
**Figure 12: Example picture for test case - person on the track**

The test cases were executed also with a high-visibility vest. It was decided that test case #1.2 does not need to be executed several times, as it provides no further insights.

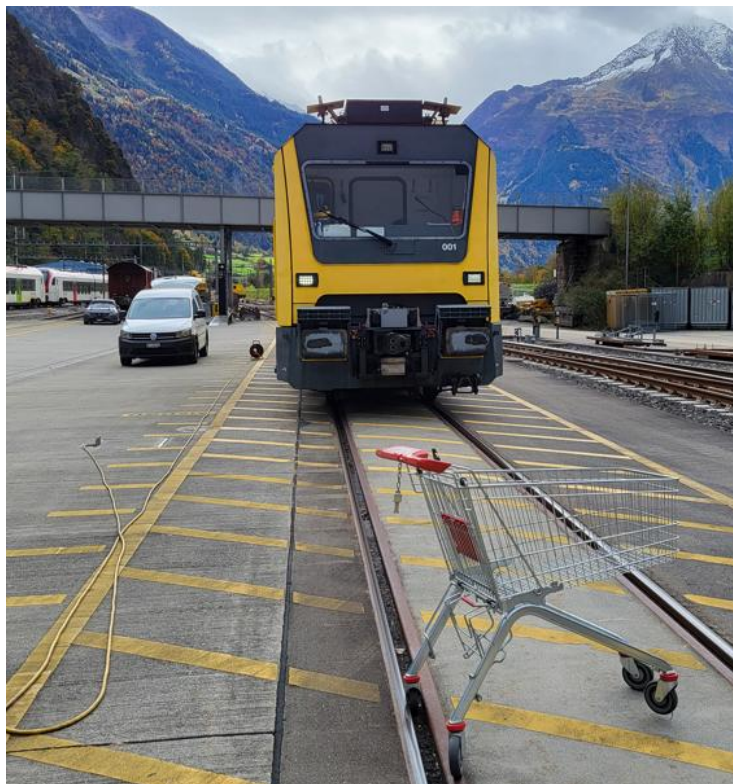
**Figure 13: Example picture for test case - object on the track (trolley)**

Remark: There was no possibility of carrying out test case #2.4. The test approach was used from tests case #3.1 and #3.2. The gate was opened halfway (static state), which then reflected the object located halfway up the vehicle in the profile area.

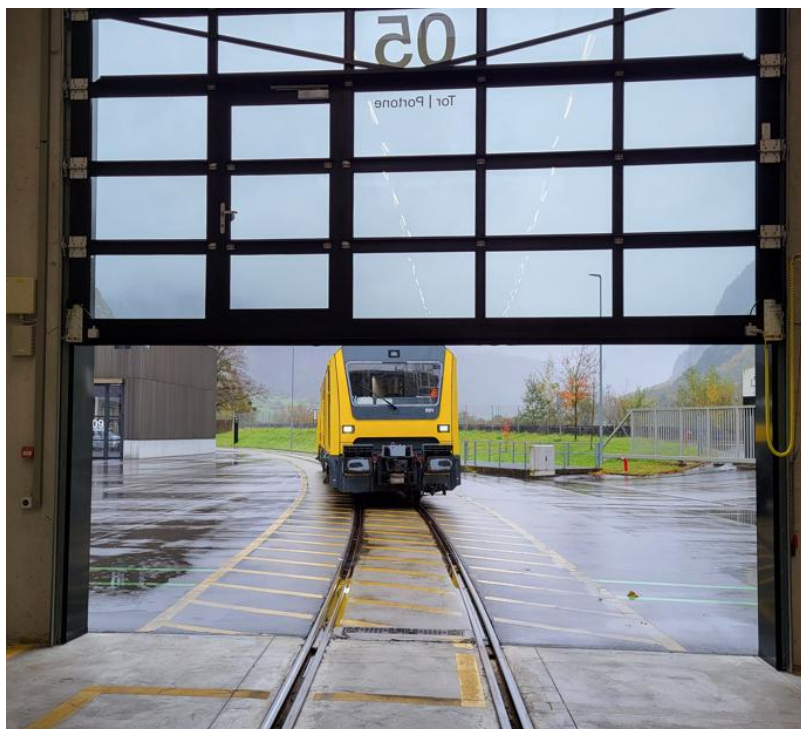
**Figure 14: Example picture for test case - opening the gate**

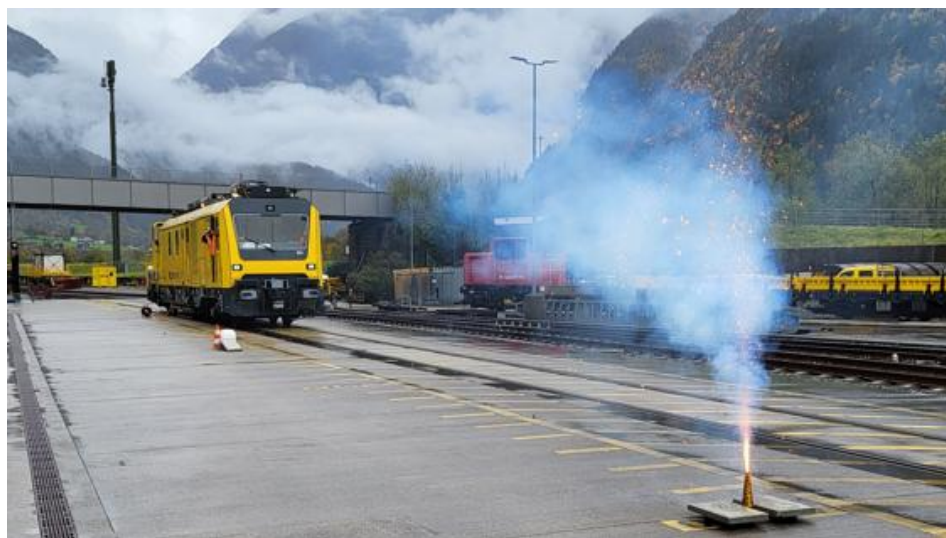
**Figure 16: Example picture for test case - fire detection**

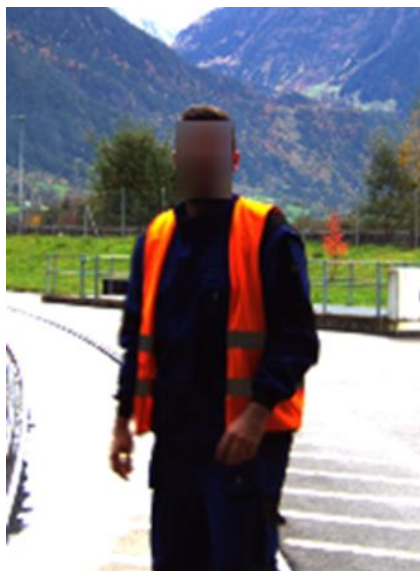
- **Automated anonymization:** In accordance with privacy requirements, the system automatically detected faces and vehicle license plates within the HD camera recordings.
- **Real-time processing:** Recognized faces (Figure 18) and license plates (Figure 19) were blurred in real-time before the data was stored on the disk.

Figure 18: Blurred face

Figure 19: Blurred license plate

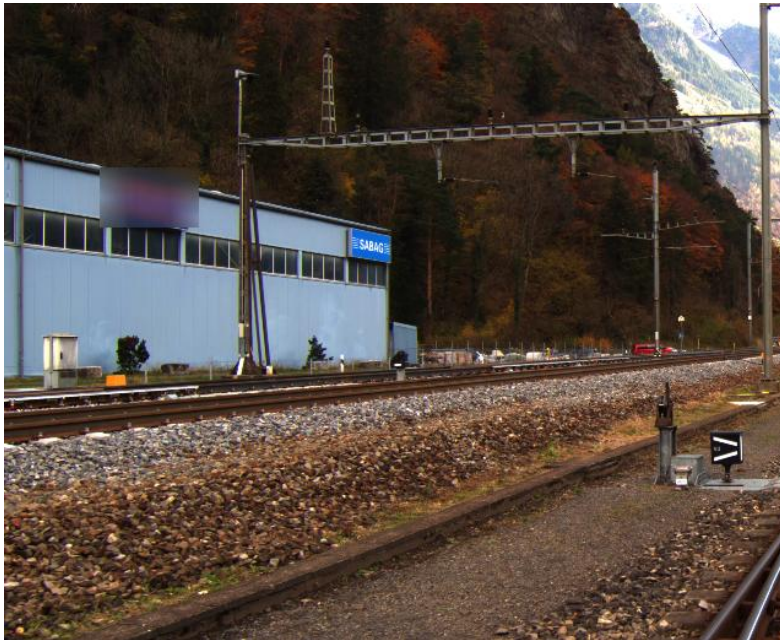
- **Computational efficiency:** To facilitate real-time processing, a mechanism was selected that prioritized being resource-efficient and time-sensitive.
- **Algorithm performance:** The applied algorithm occasionally produced "false positives", applying blur to incorrect areas - such as text or labels on the side of the train or building - that were misidentified as license plates as in Figure 20 indicated.
- **Operational impact:** These minor technical imperfections did not diminish the system's core capability to identify potential obstacles on the track.

Figure 20: False positive blurred license plate
