# **System Pillar / EULYNX**

## **Baseline Set 4 Release 2**

Version: 2.2  
Date: 17-10-2024

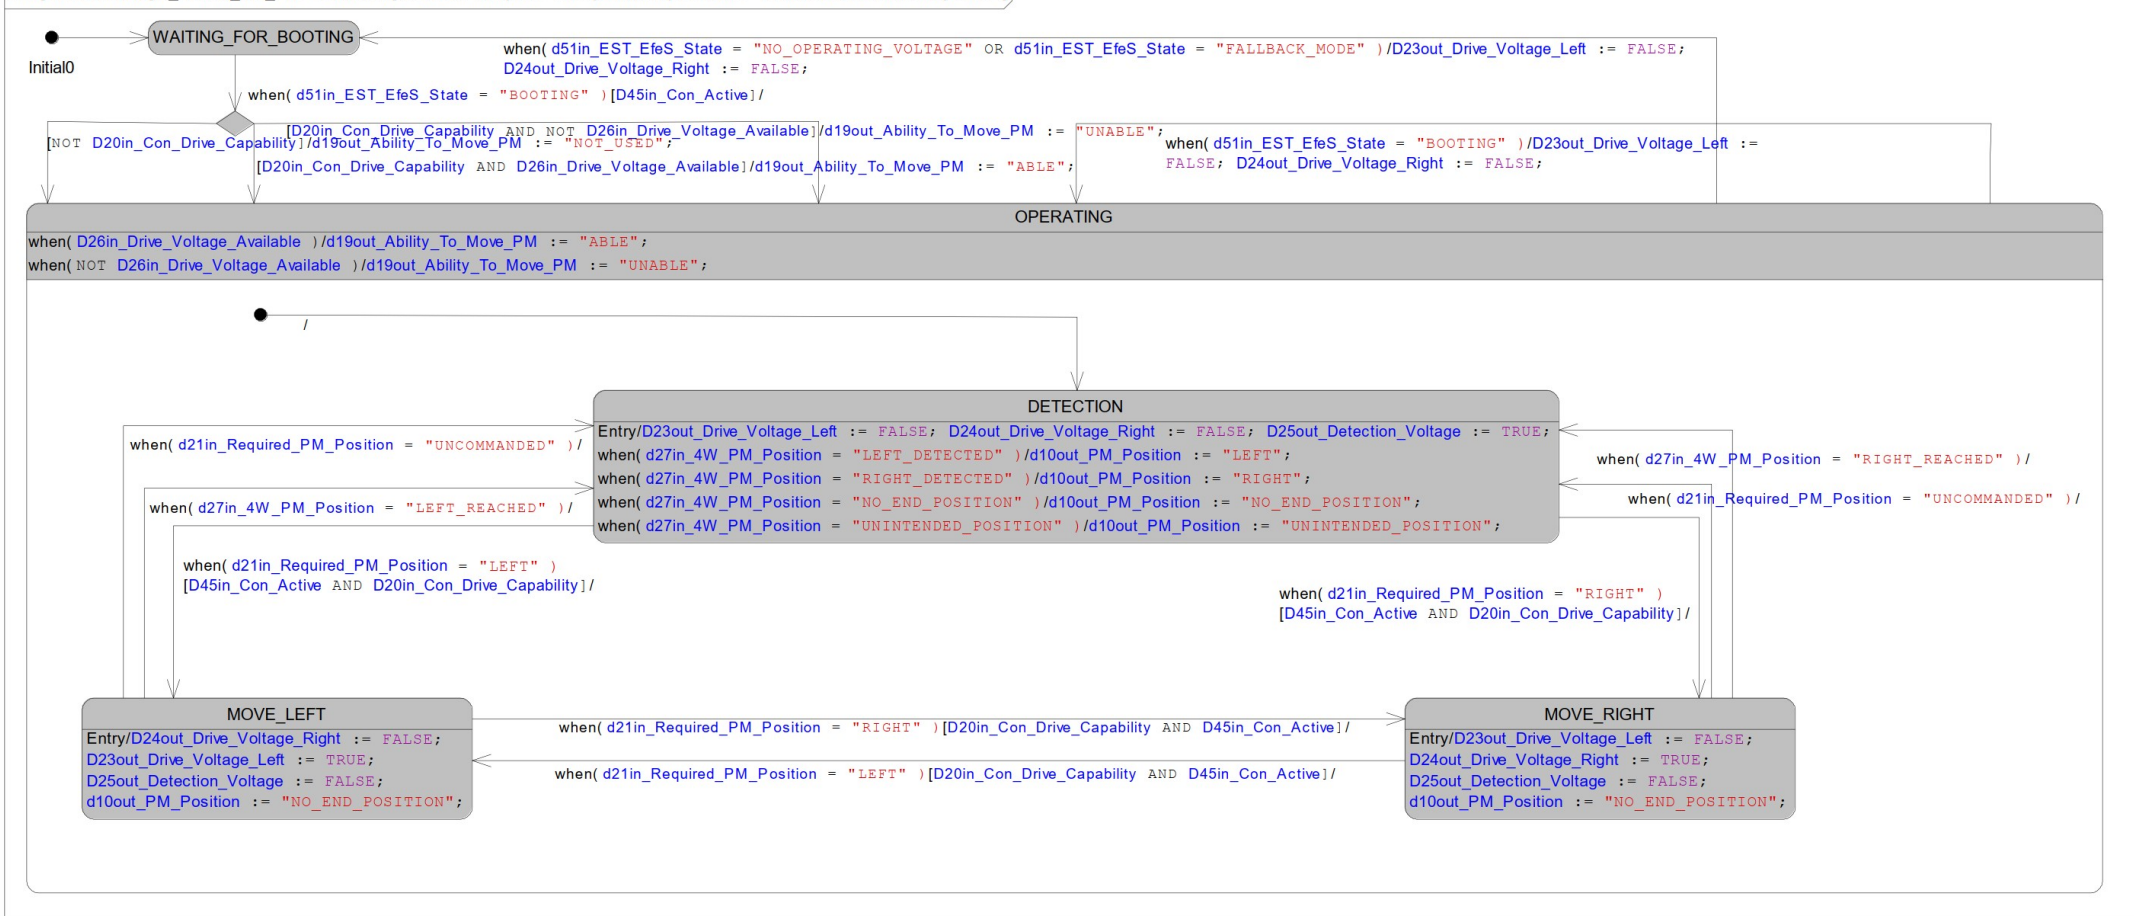
# F\_Control\_4W\_PM

stm [State Machine] F\_Control\_4W\_PM - Behaviour [Technical Viewpoint - Subsystem Requirements - Technical Functional Entity STD 1]

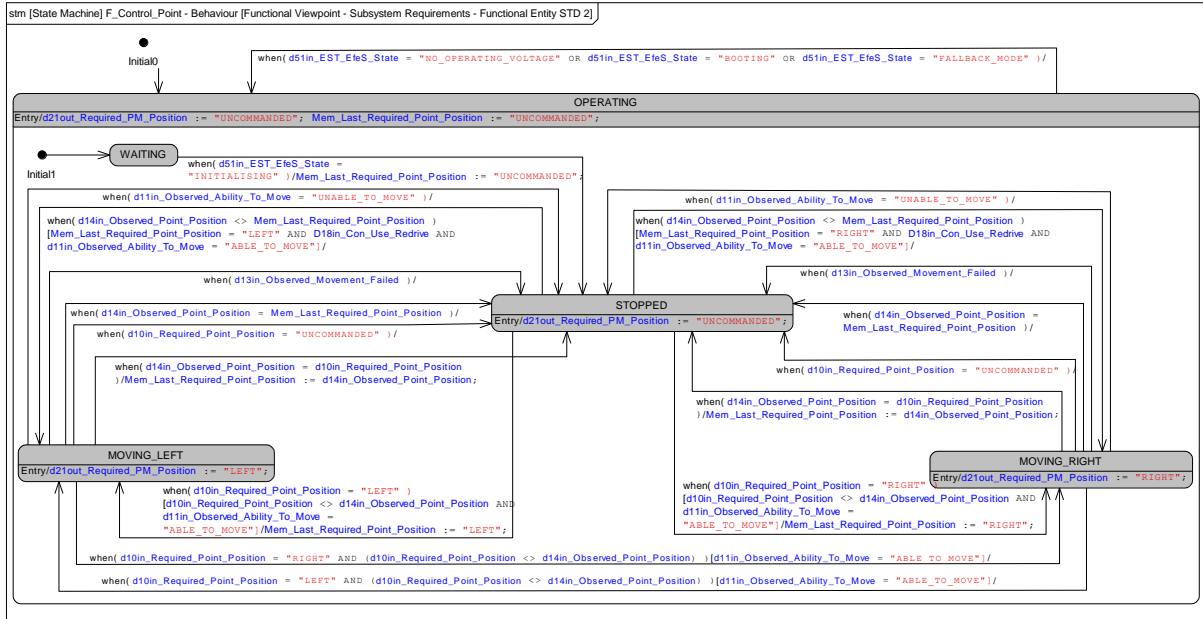
## F\_Control\_Point

# Point STMs which were basis for BL4R2/3 simulation
