PRAMS Log - Part 2 Operational Hazards

PRA MS Log - Part 2 Operational Hazards
Classification	Public
Status	Open
Version	
Revision	596653
Last Change Date	28.05.2025

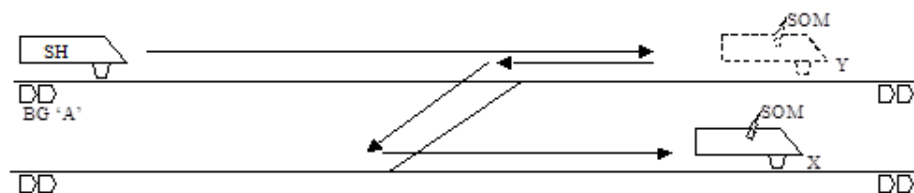
1) Movement in SH

Train enters SH mode after passing BG 'A'. ERTMS/ETCS On-Board supervises its location related to BG 'A'. When in SH, train runs backward and changes track (from the "upper" to the "lower" track, see figure). When the train arrives in position 'X', ERTMS/ETCS On-Board performs Start of Mission connecting to the RBC and giving its valid position report with BG 'A' as LRBG. As the position report is valid, RBC could think that the train is in position 'Y'. If a route is set in front of 'Y' position, RBC may send an MA for the "upper" track to the train, which is actually intended for the "lower" track.

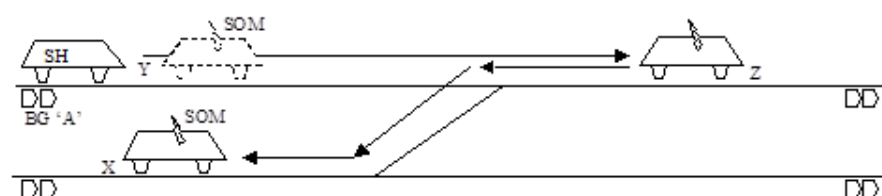
2) Change of cabin

Train enters SH mode after passing BG 'A'. ERTMS/ETCS On-Board supervises its location related to BG 'A'. When in SH, train runs up to position 'Z' and then the driver changes cabin (from the right to the left cabin, see figure).

The train runs then up to position 'X'. When the train arrives in position 'X', ERTMS/ETCS On-Board performs Start a Mission connecting to the RBC and giving its valid position report with BG 'A' as LRBG. As the position report is valid, RBC could think that the train is in position 'Y'. If a route is set in front of 'Y' position, RBC may send an MA to the train, which is actually intended for the "lower" track.

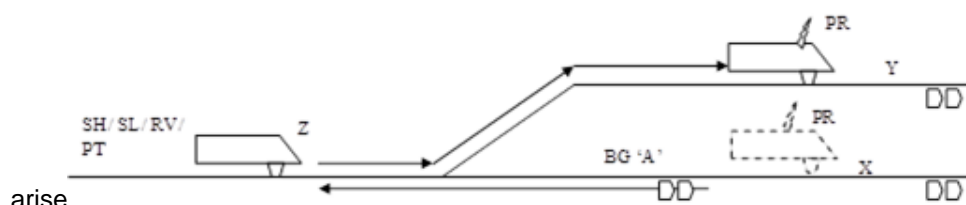
3) Train moving in backward direction

Due to constraints on the trackside it might be not possible to add or move balise groups already placed on the line. So If there is no balise group before the railway switch or balise groups on different tracks are not placed approximatively at the same distance after the switch, an ambiguity on the train position may

arise In this scenario given in the above picture the ERTMS/ETCS On-Board moves backward in SH/SL/RV/PT mode and detects only BG A. the train stops at position Z and then moves forward running on the upper part of the line. When the train is in Y, whatever if the train sends a Position Report or a SoM Position Report, the train is reporting its position as if it were in position X

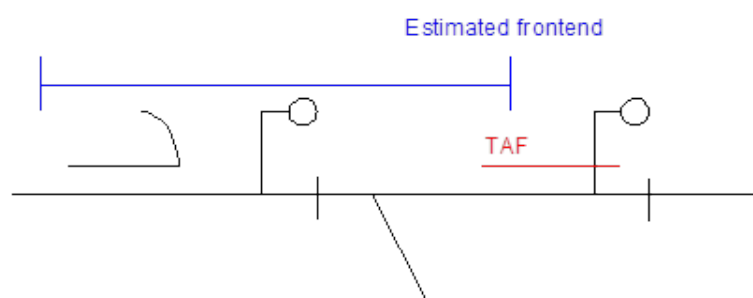
But using the estimated frontend for the delivery of TAF requests at the Trackside level can lead to hazardous situation.

Indeed, in the following situation:

The estimated frontend could be beyond the real train position in such a way that if RBC provides TAF request based on the estimated frontend, the TAF window that the ERTMS/ETCS On-Board will receive is not related to the current section (i.e. the one occupied by the train). This could lead to hazardous situation in the following case:

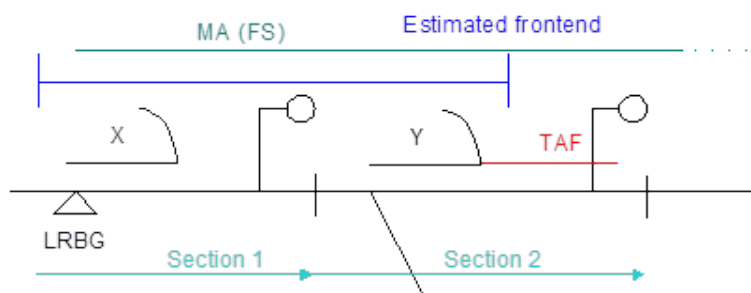
The driver of the train X grants the TAF, because he sees that the rest of section 1 is free of obstacles. The RBC will associate the received TAF granting to the TAF request it sent (i.e. the TAF request related to section 2) and therefore, will think that this section 2 is occupied by the train X only and that no other train is present on this section, while the train Y is physically occupying this section too. The RBC could therefore send to the train X a FS Movement Authority starting from the LRBG and including the section 2 occupied by the train Y.

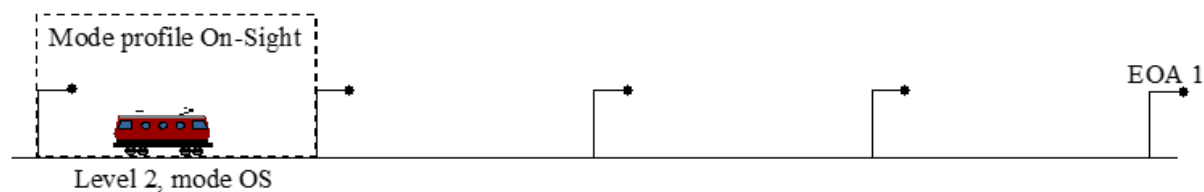
- 1) The train is in level 2, mode OS: an MA (to EOA 1) and a mode profile On-Sight are currently supervised by the ERTMS/ETCS On-Board:

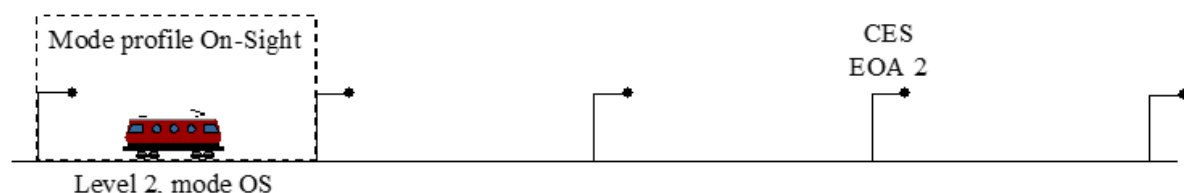
- 2) The RBC sends a Conditional Emergency Stop (to EOA 2) which is accepted and applied by the ERTMS/ETCS On-Board:

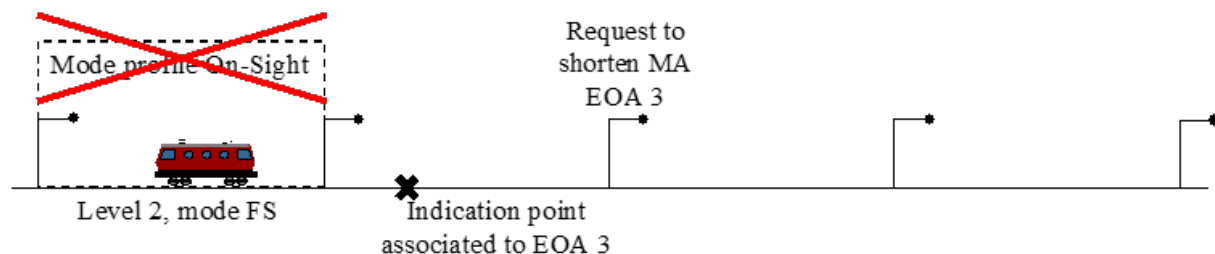
- 3) The RBC sends a Co-operative Shortening of MA (to EOA 3), which also contains the mode profile On-Sight (the same as the one currently supervised by the ERTMS/ETCS On-Board):

- According to SUBSET-026 v2.3.0 §4.8.3, modified by SUBSET-108 v1.2.0 CR 729 and CR 792, the Co-operative Shortening of MA is accepted.
- According to SUBSET-026 v2.3.0 §4.8.3, modified by SUBSET-108 v1.2.0 CR 729 and CR 792, the mode profile is rejected because a CES is in application (not yet revoked).
- According to the indication point location of the shorter MA (refer to SUBSET-026 v2.3.0 §3.8.6.1b), the Co-operative Shortening of MA is granted by the ERTMS/ETCS On-Board and the shorter MA is stored On-Board;

Nevertheless, according to SUBSET-026 v2.3.0 §3.12.4.3, as the associated mode profile has been filtered, the one currently supervised by the ERTMS/ETCS On-Board should be deleted. As a consequence, the train could switch to Full Supervision mode in an On-Sight area.

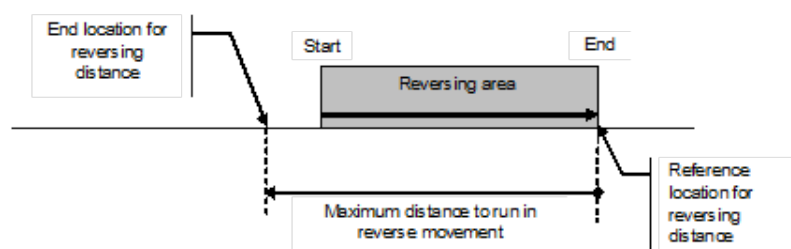
In Reversing mode the trains are allowed to run for a maximum distance, given by trackside: the ERTMS/ETCS On-Board calculates the permitted end location using as a fixed reference location the end of the Reversing Area (also given by trackside):

The RBC can update both the Reversing Area and the maximum distance to run; if the ERTMS/ETCS On-Board is in reversing mode however it rejects any new Reversing Area received. Therefore, should the RBC update both Reversing Area and maximum distance to run, the ERTMS/ETCS On-Board in RV would filter out the new Reversing Area info, which however defines also the starting point of the new maximum distance to run. The ERTMS/ETCS On-Board would then calculate the new end location for the

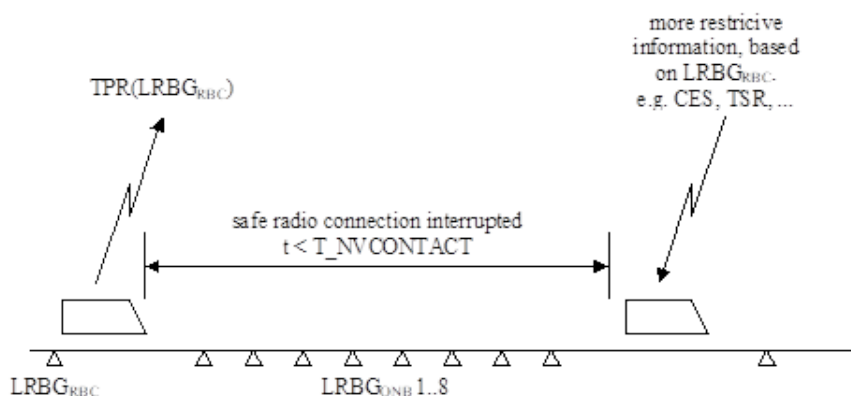
of passed balise groups not reported to the RBC may exceed the maximum number that shall be stored by the ERTMS/ETCS On-Board. This means that the last reported LRBG is not stored in the ERTMS/ETCS On-Board anymore.

After re-establishing the safe connection, the RBC tries to send an urgent/more restrictive message (e.g. conditional/unconditional emergency stop, TSR, shortened MA) to the ERTMS/ETCS On-Board and uses the LRBGRBC as a reference, which was reported by the ERTMS/ETCS On-Board equipment (see §3.6.2.2.2.b, which interferes with §3.10.2.1.3 – for v2.3.0 – and with §3.10.2.3 – for v3.4.0 and v3.6.0 – for unconditional emergency stops). But the ERTMS/ETCS On-Board may reject this new message from the RBC, because the used LRBGRBC is not referring to one of at least eight LRBGONB.

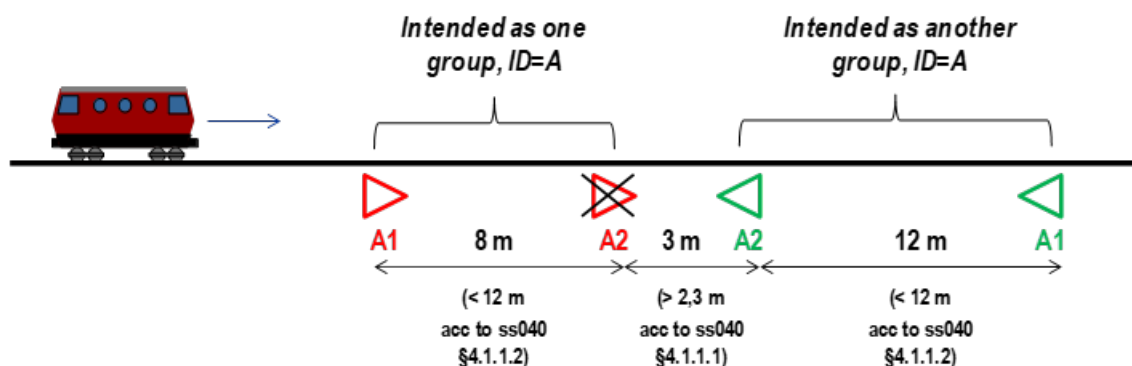
Example 2

If two balise groups with the same identity are placed close to each other and one of the closest balises is not read by a passing train, ERTMS/ETCS On-Board may create a "ghost" balise group from one balise in each group. This can lead to hazardous situations: see below:

A new "ghost" group is created from red A1 + green A2 (<12m). The new group could have lost restrictive info from the red group and/or picked up permissive info (valid in nominal direction, which is now to the right) from the green group.

- 1) If green A1 still works: restrictive reaction according to SUBSET-026 v3.4.0 and v3.6.0 §3.16.2.5.1 approximately 12m after passing green A1 (delayed compared to engineering intention).
- 2) If green A1 is also silent: train will continue with the new erroneous information.

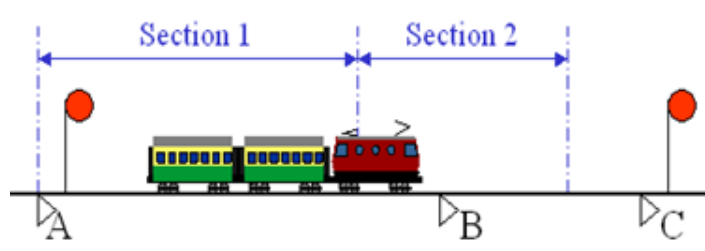
Before repositioning: the MA is stopped before the red signal

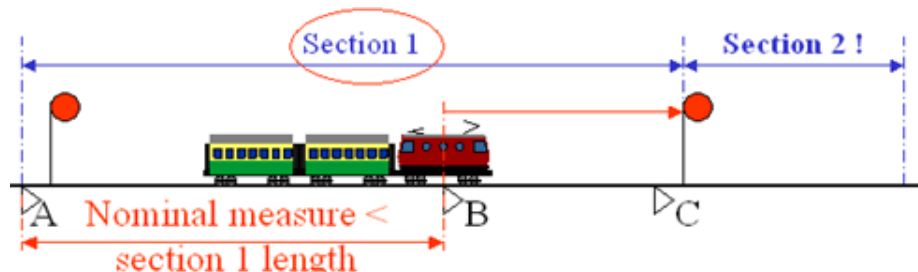
The BG B is considered in section 1, because of measure inaccuracy in the distance estimation, whereas it is physically in section 2, then the MA is extended up to location in advance of the red signal

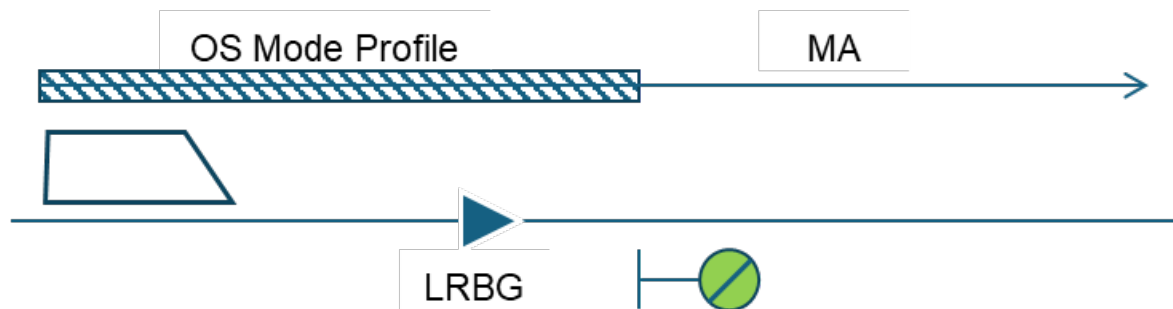
- a) Start of Mission after a change of driving cab, with on-sight mode profile up to the next signal and MA extended beyond this signal:

In case there occurs a restriction inside the MA and the RBC is required to shorten this MA by means of a Request to Shorten MA (message 9) before the train has passed the LRBG, it cannot do this because D_REF is not defined for message 9.

Doing this without regarding D_REF, based on the LRBG location, this would remove the OS mode profile from the train's front end up to the LRBG.

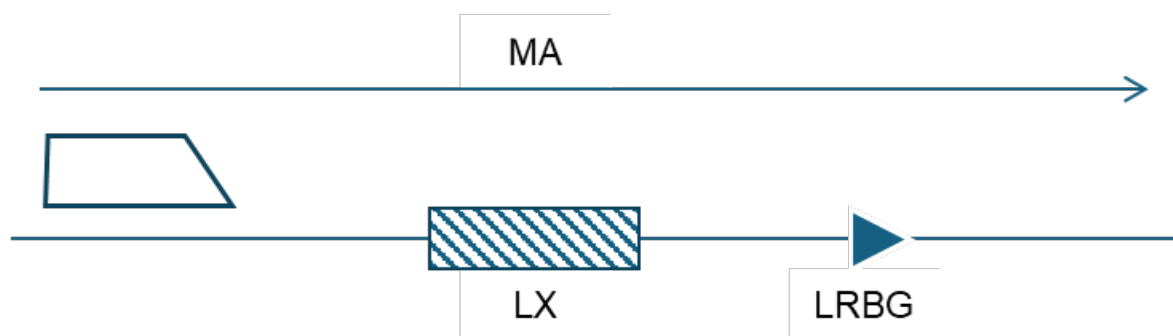
- b) Start of Mission in rear of a 'protected' level crossing with MA up to a location beyond the level crossing:

In case the level crossing changes its state to 'not protected' or 'faulty', the RBC is required to update the LX information for the train, by means of LX information or TSR packets, with the same shifted location reference (D_REF). This is not possible because D_REF is not available for a general message (message 24).

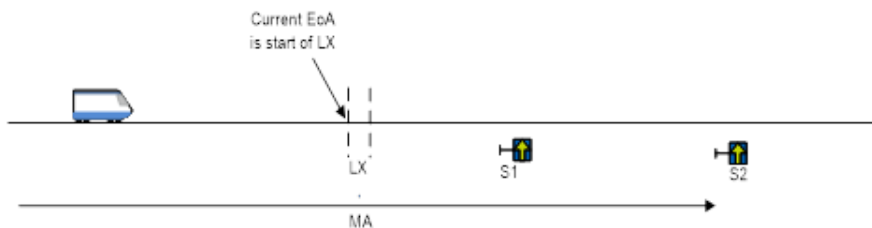
1. ERTMS/ETCS On-Board receives MA (up to S2) with LX profile.
2. ERTMS/ETCS On-Board considers the start of the unprotected LX as temporary EoA/SvL (S-026 v3.4.0, §5.16.1.1).

3. ERTMS/ETCS On-Board receives a Conditional Emergency Stop (with emergency stop location at S1) from RBC for a location beyond the LX, but in rear of the EoA given by the previous MA.
4. ERTMS/ETCS On-Board accepts the CES, but it does not define a new EoA/SvL because the location is beyond the current (temporary) EoA (if the temporary EoA/SvL is considered as current EoA/SvL; SUBSET-026 v3.4.0 and v3.6.0, §3.10.2.2, 2nd bullet resp. SUBSET-026 v2.3.0 §3.10.2.1.2 2nd bullet).

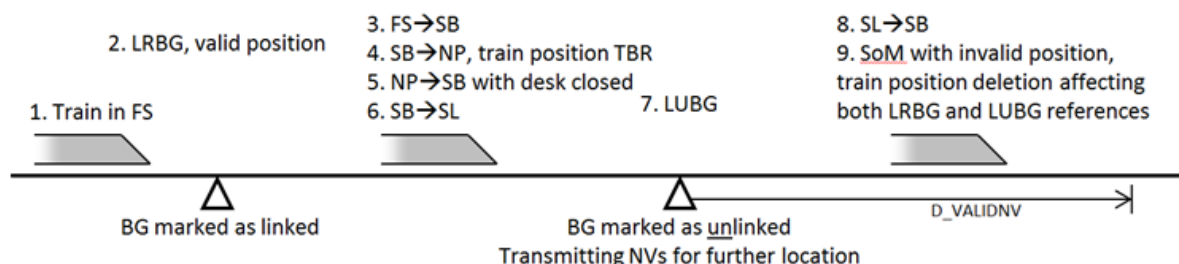
The train is running with an unknown train position or in SL with an invalid train position.

The train encounters a balise group marked as unlinked which provides national values for application at a further distance i.e. the D_VALIDNV variable in the packet 3 provided by this balise group is different from zero (it is e.g equal to 1000 m).

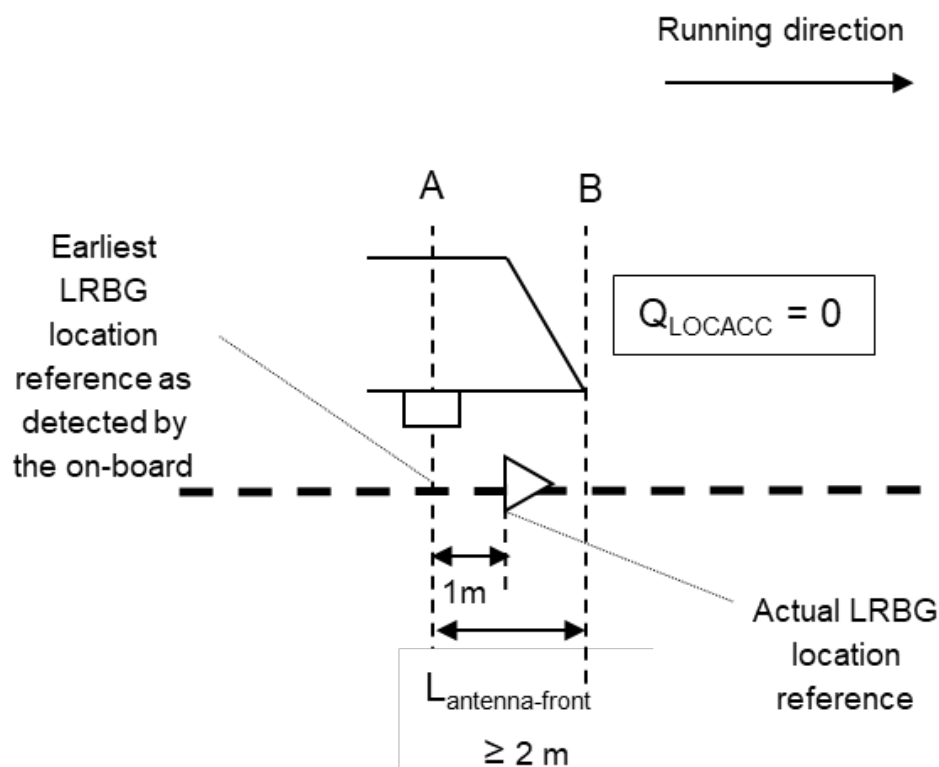
Making reference to the figure below (and for simplicity disregarding the location accuracy of the BG, which is anyway a trackside parameter that the IM can control) trackside engineers (/infrastructure managers) might have done the following reasoning:

- 1) The LRBG location reference as detected by the on-board can be at most 1 m in rear of the actual location reference of the balise group (location A), as per SUBSET-036 §4.2.10.2
- 2) Since the distance between Eurobalise antenna and train front is $\geq 2\text{m}$ (SUBSET-040), the ETCS/ERTMS On-board equipment will consider that it is “physically certain” that the front end is at, or beyond, location B and so it will set the min safe front end not in rear of location B
- 3) If the EoA is in rear of location B, the train is surely tripped, independently of any odometry inaccuracy defined in Subset-041.

So by putting the EoA in rear of location B, the infrastructure manager is sure that by the time the ETCS/ERTMS on-board equipment has processed the balise group message it is sure that the train is tripped.

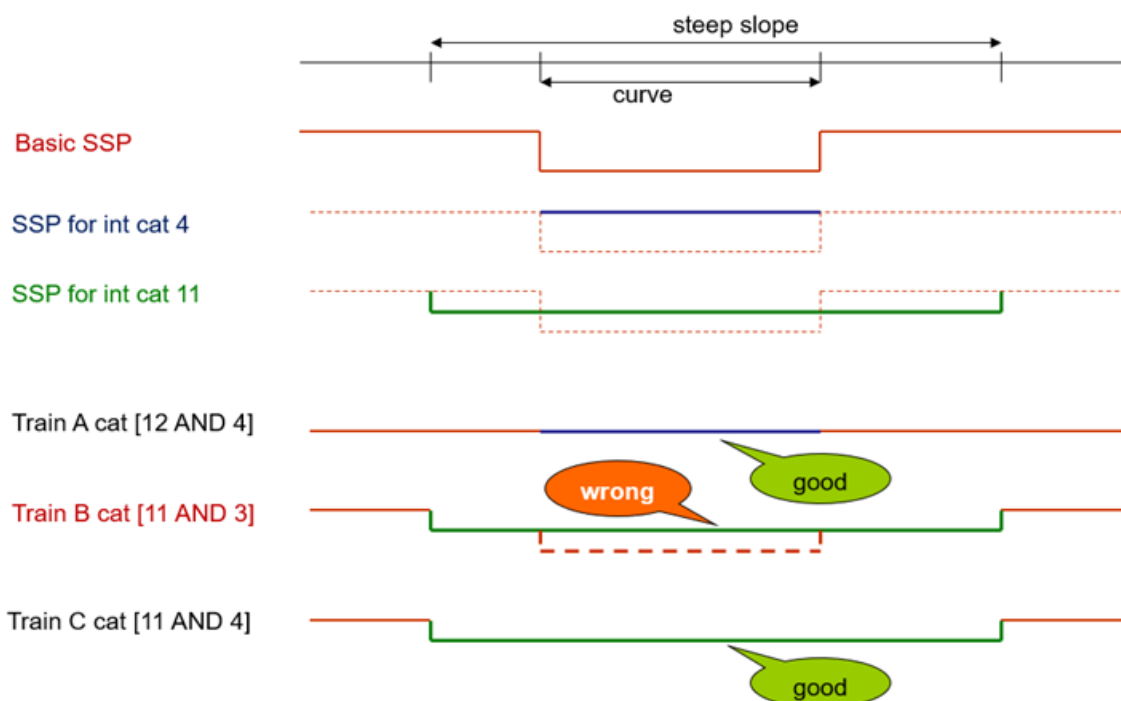
The result:

The OBU of train B ignores the basic SSP, because trackside has sent SSP matching one of the train categories train belongs to. By doing this, in the curve the train can run at a speed that is too high for its suspensions design. The basic SSP (computed for 80 mm CD) would have been on the safe side for this train, but the OBU ignores it, resulting in a hazard.

Brake position	Admissible cant deficiency	Resulting international train categories in 230d
Train A	Passenger in P	130 mm	12 and 4
Train B	Freight in G	100 mm	11 and 3
Train C	Freight in G	130 mm	11 and 4

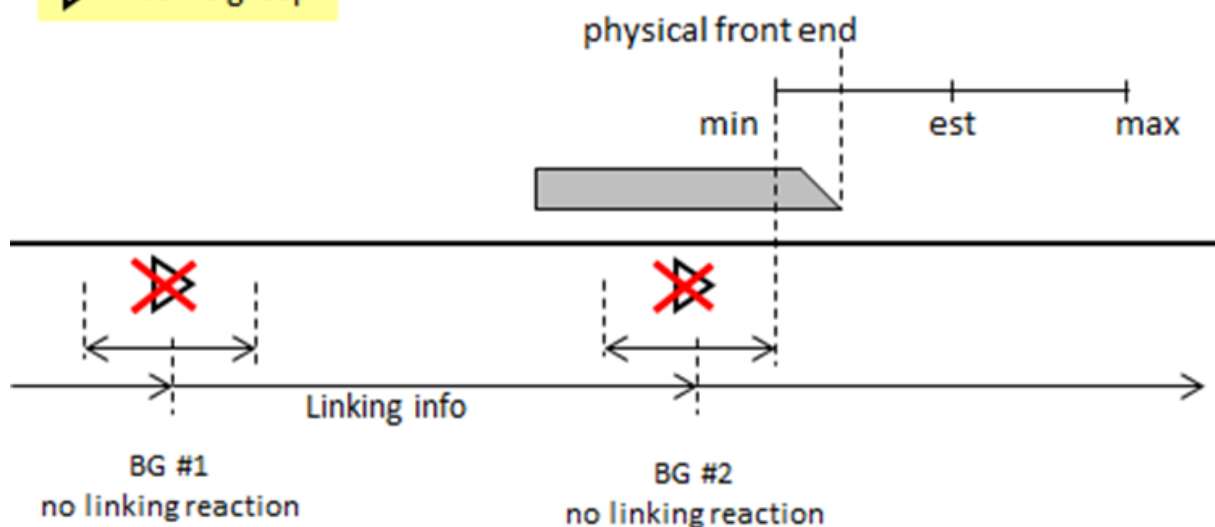
For the case that the information cannot be transmitted via any of the two balise groups, the trackside may expect that the service brake is applied when "the end of the expectation window of the second balise group has been passed" as per SRS clause 3.16.2.7.1.1.

▷ : balise group

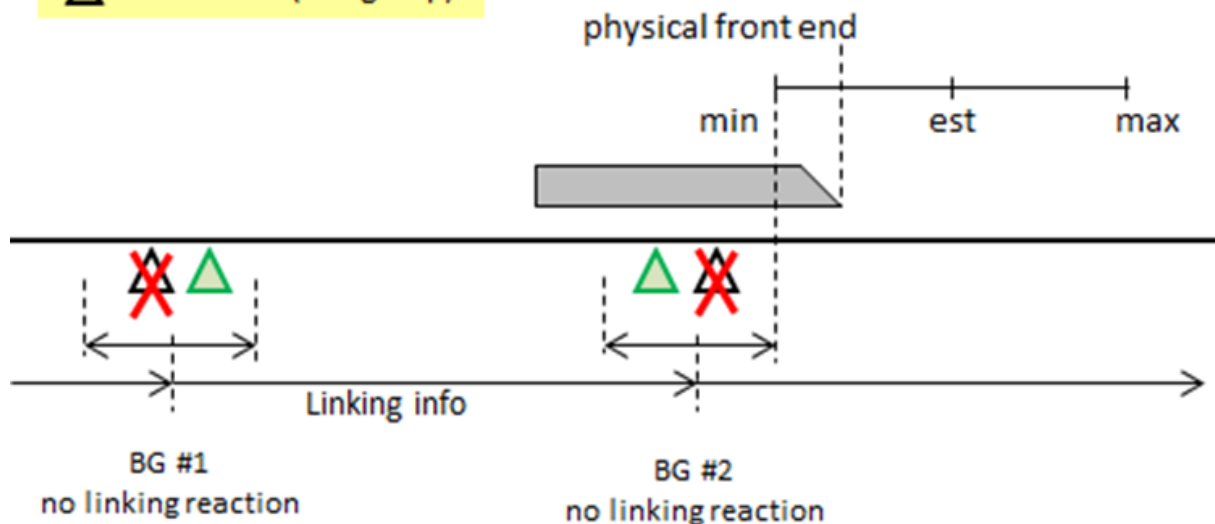
For the case that in both BGs one balise out of the group is malfunctioning while the other one works properly, the information will not be taken into account at all (neither via BG #1 nor via BG #2) due to the SRS clause 3.16.2.4.1.

△ : one balise (of a group)

Since the ERTMS/ETCS on-board detects one balise out of each balise group the on-board concludes that SRS clause 3.16.2.7.1.1 ("If 2 consecutive linked balise groups announced by linking are not detected ...") does not apply.

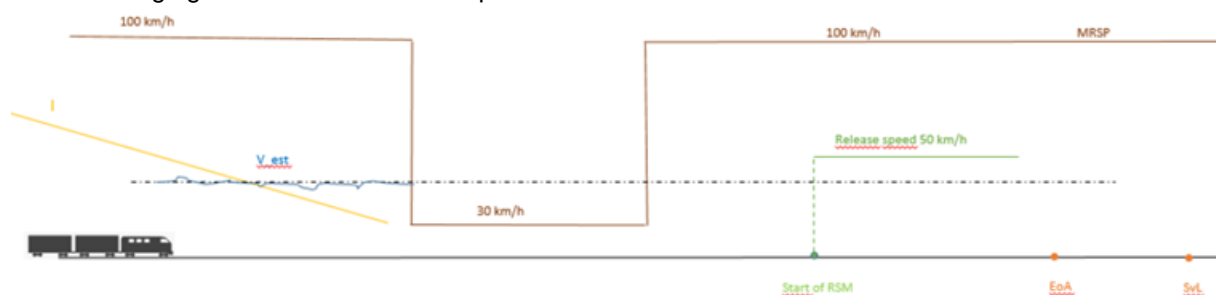
The following figure illustrates one example of the conditions that will lead to the hazard

location corresponds to a supervised target EoA/SvL. Another possible interpretation is that it corresponds to a situation where a release speed “exists”. This last interpretation is problematic because it could lead to not supervising the targets with a speed value lower than the release speed and located between the max safe front end of the train and the start of the RSM area, when the train speed is lower than the release speed, because the conditions for entering in TSM for those targets will not be fulfilled (see SUBSET-026-3, table 16). Please take note that according to this table, and in the case of “a release speed is supervised”, the condition 1 only applies if “the train speed is above or equal to the release speed”.

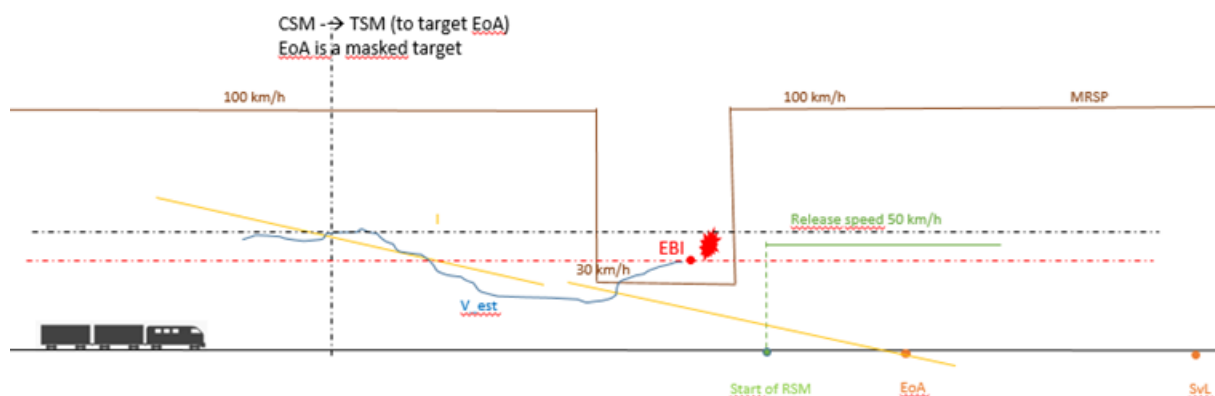
Figure 1: the train enters TSM and the EOA is selected as MRDT at a speed higher than the release

speed and after overpasses V_{MRSP} up to the triggering command limit

According to SUBSET-026, v3.4.0 and v3.6.0, if the train speed overpasses V_{MRSP} while being in TSM and a change of status/command is applied (table 9, t6, t9, t12 or t15), the status/command is automatically revoked when the train reaches a speed equal or lower than the release speed (SUBSET-026 table 11, r1). If the value of V_{MRSP} is lower than the value of the release speed, this would imply to release the status/command sooner than expected, and in some cases even immediately, something that could lead in specific situations to a safety issue, e.g. for the case of a EB command immediately revoked due to having a release speed value higher than the one corresponding to the EBI limit

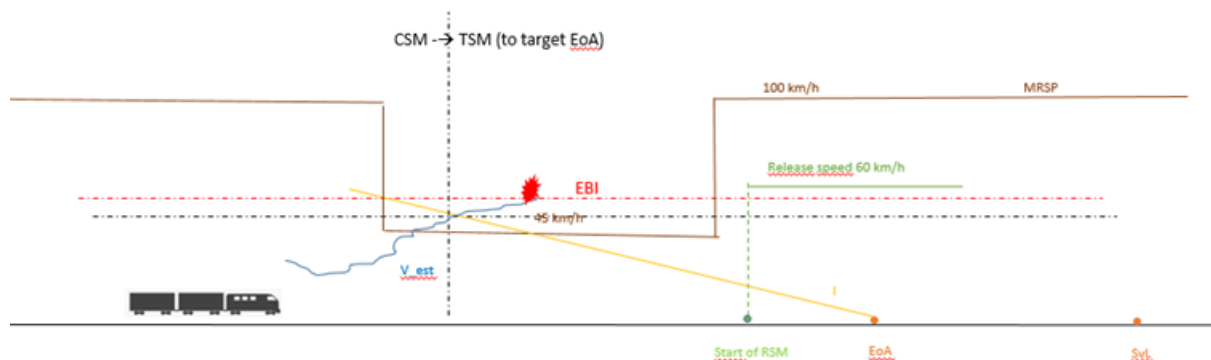
Figure 2: The train accelerates in CSM over V_{MRSP} , enters in TSM at a speed lower than the release speed and reaches the triggering command limit

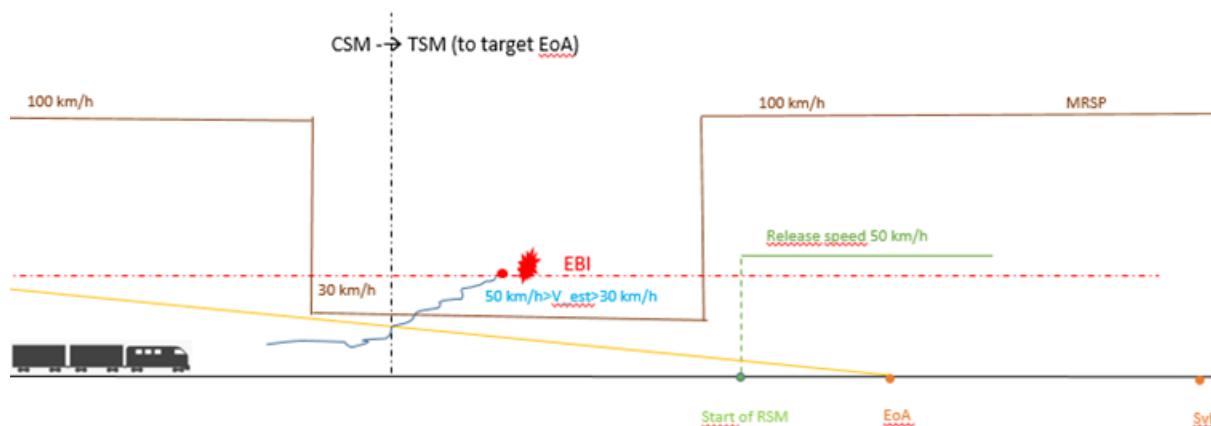
Figure 3: the train enters in TSM at a speed lower than the release speed and increases the speed over V_{MRSP} up to the triggering command limit.

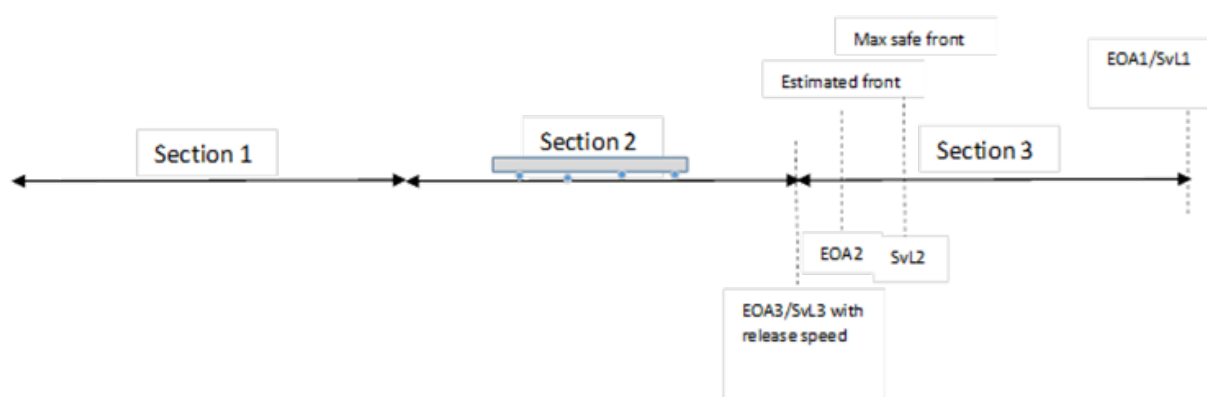
An event occurs which triggers A.3.4.1.3 condition [11]. The ERTMS/ETCS On-board equipment shall consider the current estimated front end and max safe front end positions of the train, as the EOA and SvL respectively, with no release speed. Therefore, the EOA1/SvL1 are shortened to the estimated front end/maximum safe front end respectively -> EOA2/SvL2 with no release speed.

The timer related to section 3 expires and the requirement in 3.8.4.2.2 is triggered. The EOA2/SvL2 move to the start of the section 3 (EOA3/SvL3).

In this case the EOA and SvL are both “withdrawn” upon expiry of the section timer, the same hazardous situation applies: the train is allowed to proceed with the national value for the release speed, when the trackside would expect that the train should not be able to move forward at all after the application of condition [11].

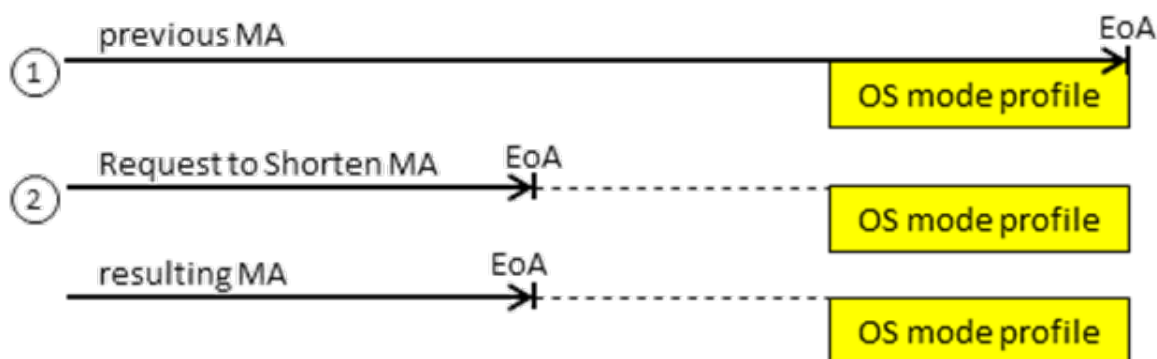
An ERTMS/ETCS-On-board receives an MA with an OS mode profile for further location, and the beginning of the mode profile is beyond the EOA of the MA:

1. ERTMS/ETCS On-board has MA on-board with OS mode profile that starts before and ends at the EoA.
2. RBC sends Request to Shorten MA to ERTMS/ETCS On-board with requested stop location in rear of the start of OS mode profile. As an alternative mitigation for the example 1 of ETCS-H0082 the RBC sends together with the Request to Shorten MA a OS mode profile that equals the mode profile currently stored on-board.
3. ERTMS/ETCS On-board accepts the Request to Shorten MA and OS mode profile.

SUBSET-026 v.3.6.0 §5.9.3.5 defines a requirement

“...Until the ERTMS/ETCS on-board equipment has switched to OS mode, the beginning of the On Sight area shall be temporarily considered as the EOA (instead of the EOA/LOA derived from the MA) and the SvL (with no release speed) shall be determined according to the mode profile either:
