#### **COVER DOCUMENT**

# System Pillar / EULYNX Baseline Set 4 Release 2

Version: 2.4 Date: 30-06-2025

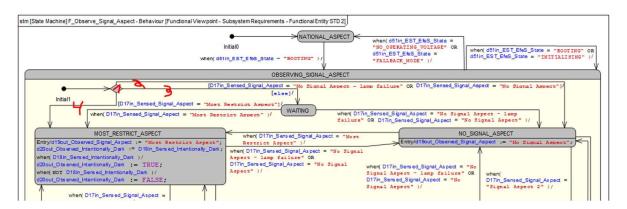
### image-2023-08-15-13-44-53-576.png

The STM for observe Signal Aspect shall be extended with transitions made of purely guard conditions (reacting on current state and not change trigger) as in attached pic shown. The four marked transitions/elements should be added to correct the described behaviour above.

This is caused due to a deadlock in the observing block as it reacts just on the change trigger of D17 and can therefore not leave the state WAITING.

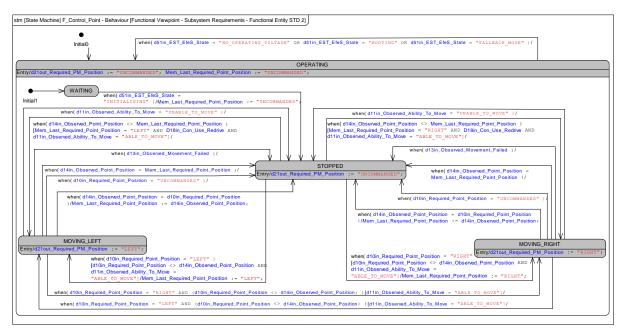
# F\_Control\_Point

# Point STMs which were basis for BL4R2/3 simulation
